2010 Pre – Post Gordon Creek Monitoring Report

Southern Wisconsin Chapter of Trout Unlimited

Dave Marshall, Underwater Habitat Investigations LLC

August 2010

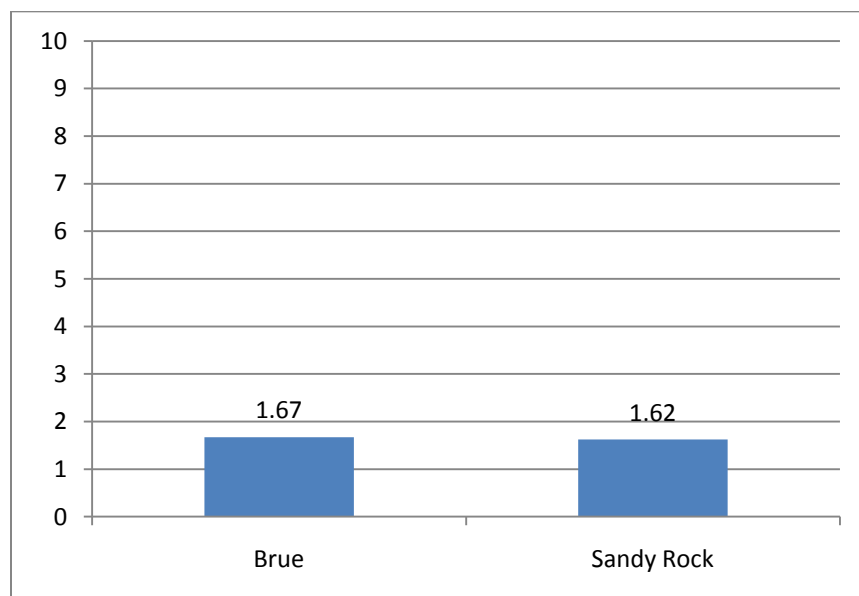
Figure 1: Family-level Biotic Index Results (< 3.75 = excellent water quality)

Macroinvertebrate communities at both sites were very similar and reflected “excellent” water quality based on the family-level biotic index (Figure 1). The macroinvertebrate families are represented in Figure 2 and included environmentally intolerant stoneflies (Plecoptera), mayflies (Ephemeroptera) and caddisflies (Tricoptera).

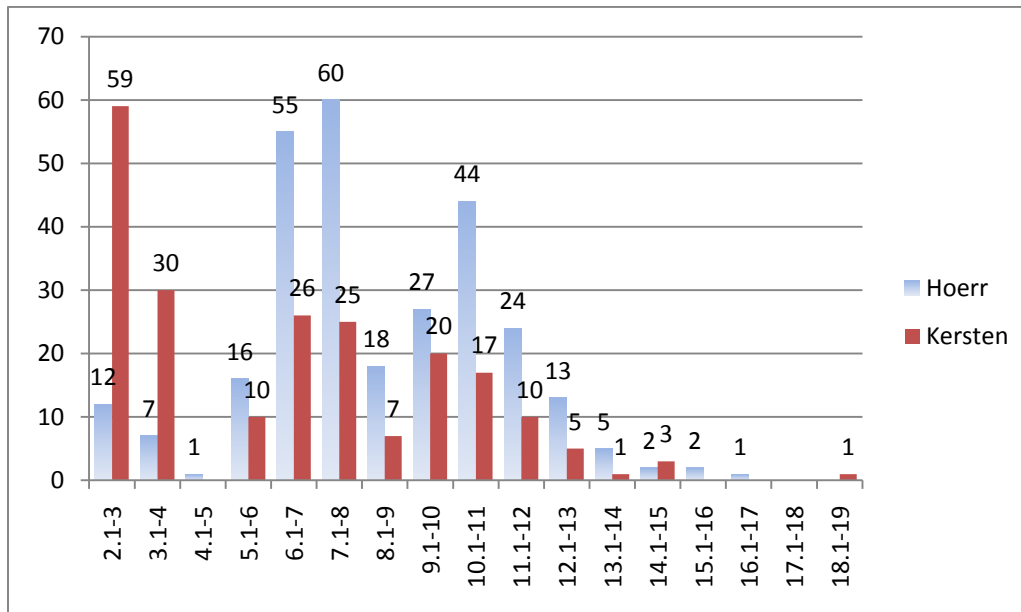
Figure 5: Brown trout size distribution

The surveys revealed that classic trout stream “indicator” nongame fish including mottled sculpin and American brook lamprey were found in very low numbers. Combined with the high density of brown trout (>1,000/mile), the fish community data suggests that brown trout may be over-populated in the stream. This issue warrants further investigation and discussion. The data also revealed an apparent higher trout density along the Kersten property before restoration. While box elder snags and debris dams can provide trout cover, the two stream

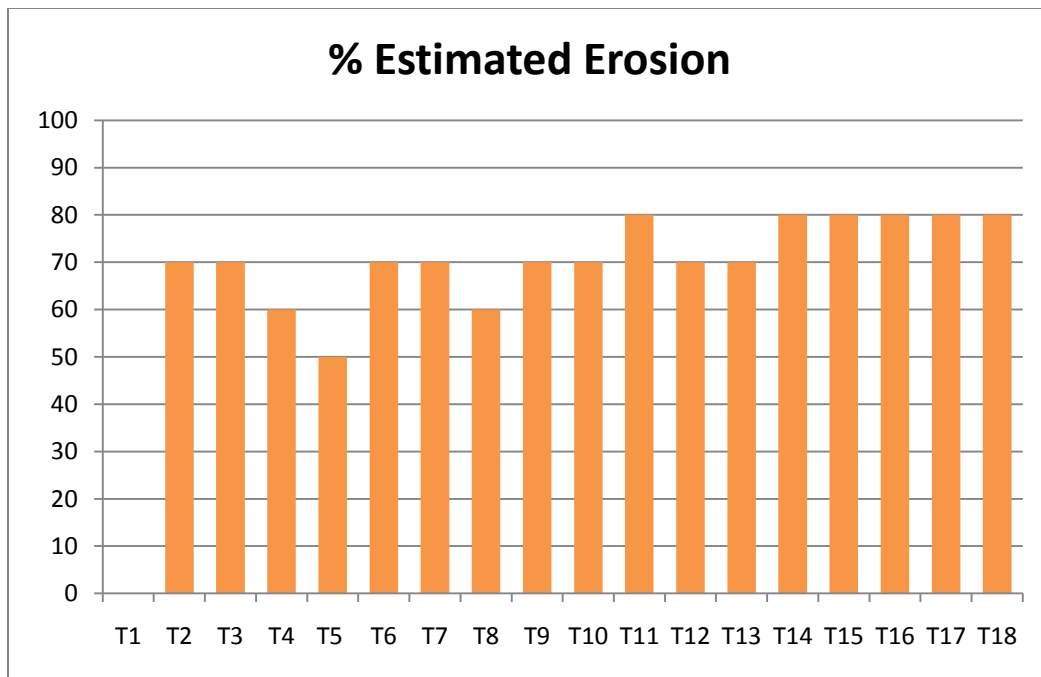
Figure 6: Erosion rates along the Kersten property prior to habitat restoration

We collected stream profile information, light, shading and bank erosion estimates along approximately 1700 feet of stream (Table 1) that preceded restoration. Stream cross section data was collected every 100 feet beginning at the south end of the Kersten property. Estimated bank erosion rates ranged from approximately 50% to 80% frequency (Figure 6). The erosion was linked to box elder shading that prevented the stability of grass cover and an entrenched channel that lacked frequent connection to the floodplain. Box elder canopy cover ranged from 30% to 100% shading (Figure 7). As expected, light (measured as photosynthetic wavelengths) was inversely related to shading as light was significantly reduced as shading increased (Figure 7). Profile data from one of 18 transects is displayed to demonstrate channel entrenchment. The space between the red line (channel definition) and green line represents soft sediment deposits, partly associated with erosion and deposition.

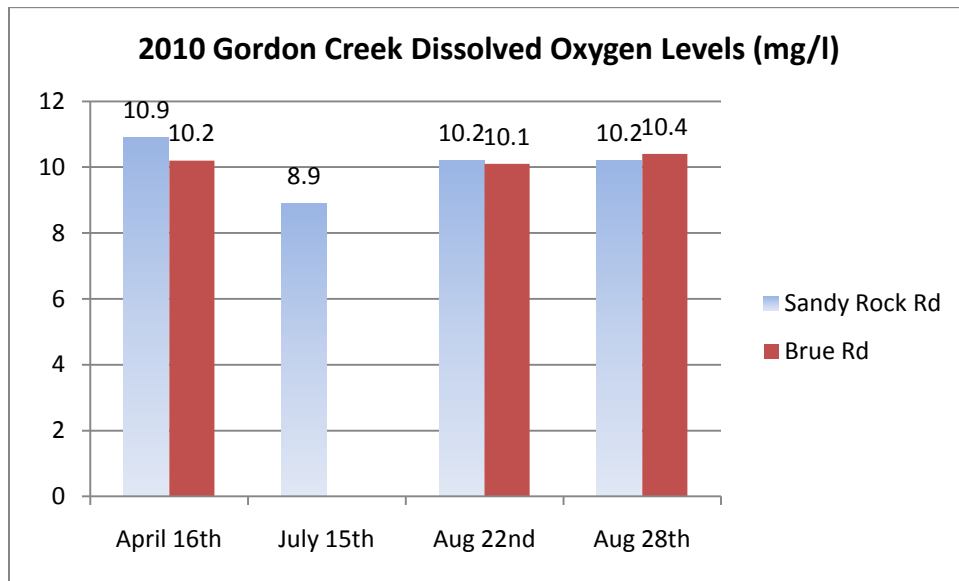
Figure 13: Gordon Creek Dissolved Oxygen Levels

All measurements were well above minimum criterion.

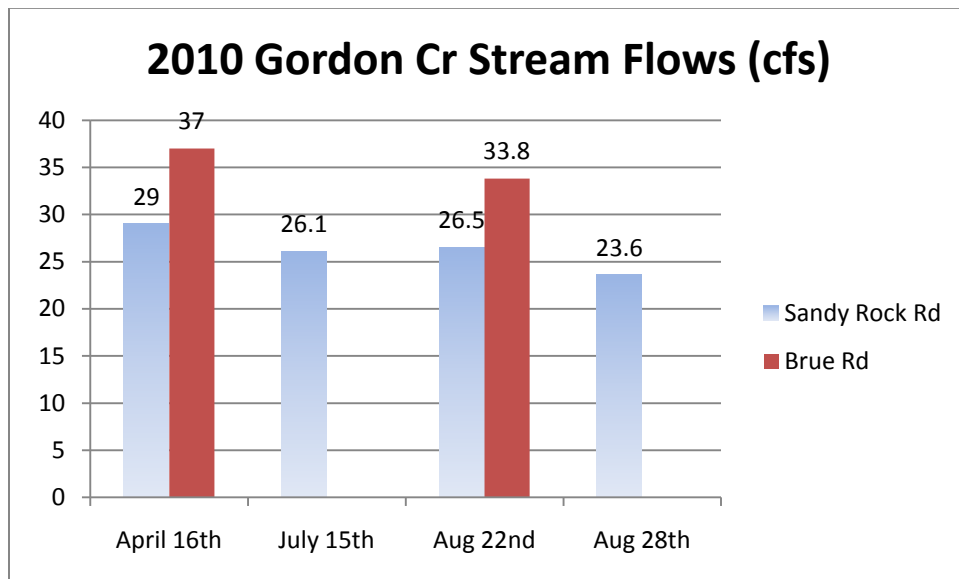
Figure 14: Gordon Creek Flow Measurements

Flow increases substantially between Sandy Rock Road and Brue Road. At Sandy Rock Road, water level at 1.7' = 26.5 cfs and 1.65' = 23.6 cfs.
