2010 Pre – Post Gordon Creek Monitoring Report

Southern Wisconsin Chapter of Trout Unlimited

Dave Marshall, Underwater Habitat Investigations LLC

August 2010

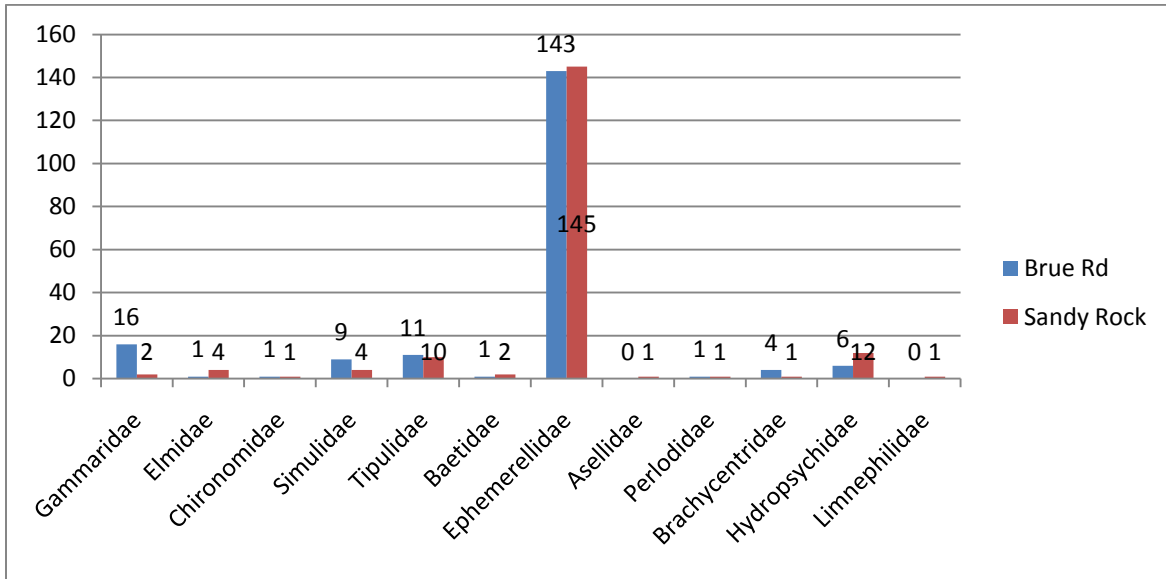
Figure 2: Macroinvertebrate Families

Macroinvertebrate communities at both sites were very similar and reflected “excellent” water quality based on the family-level biotic index (Figure 1). The macroinvertebrate families are represented in Figure 2 and included environmentally intolerant stoneflies (Plecoptera), mayflies (Ephemeroptera) and caddisflies (Tricoptera).

Gammaridae= scuds or side swimmers, Elmidae = riffle beetles, Chironomidae = midges, Simuliidae = black flies, Tipulidae = crane flies, Baetidae = mayflies, Ephemerellidae = mayflies, Asellidae = sowbugs, Perlodidae = stoneflies, Brachycentridae = cased caddisflies, Hydropsychidae = case less caddisflies, and Limnephilidae = cased caddisflies.

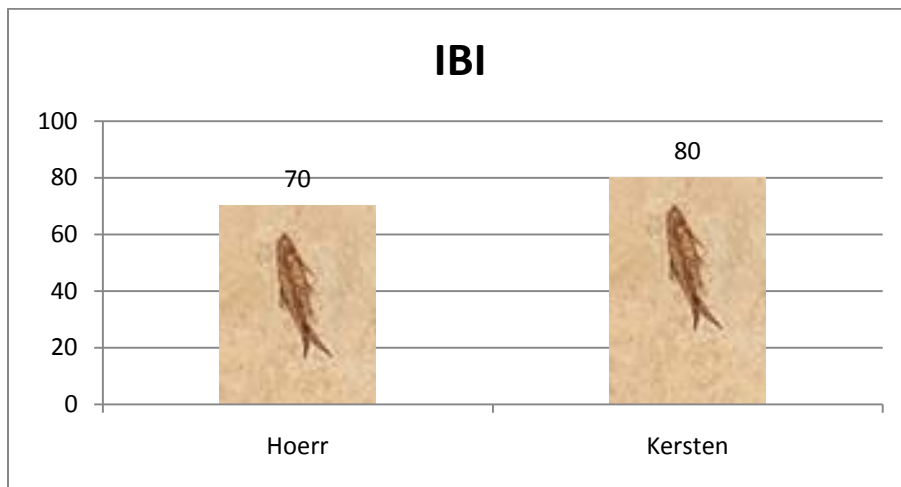
Figure3: Coldwater IBI. IBI scores ranging from 60 – 80 indicated good environmental conditions.

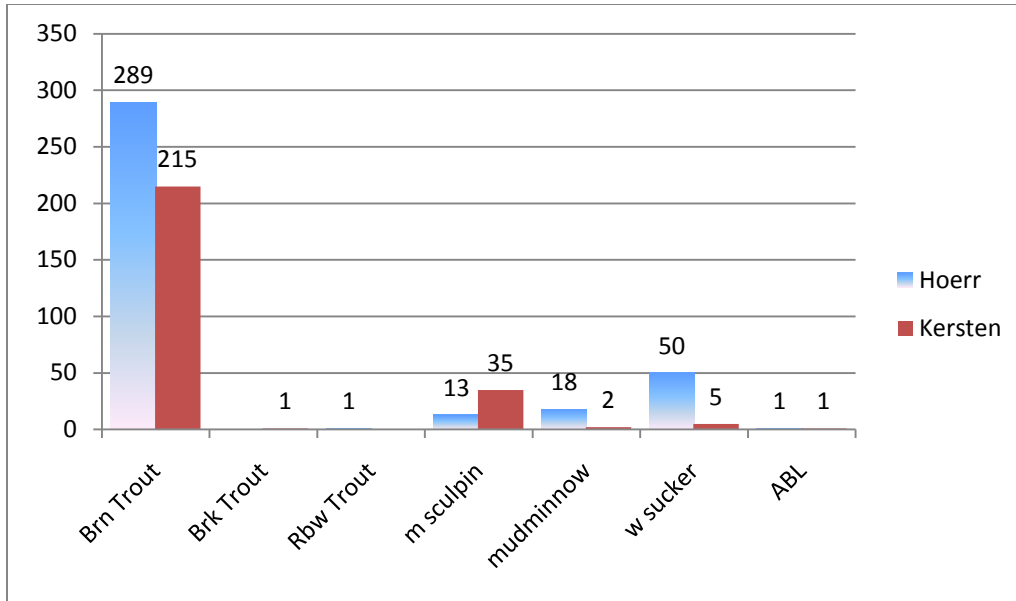
Figure 4: Fish species composition. Brown trout, brook trout, rainbow trout, mottled sculpin, mudminnow, white sucker and American brook lamprey.

The surveys revealed that classic trout stream “indicator” nongame fish including mottled sculpin and American brook lamprey were found in very low numbers. Combined with the high density of brown trout (>1,000/mile), the fish community data suggests that brown trout may be over-populated in the stream. This issue warrants further investigation and discussion. The data also revealed an apparent higher trout density along the Kersten property before restoration. While box elder snags and debris dams can provide trout cover, the two stream

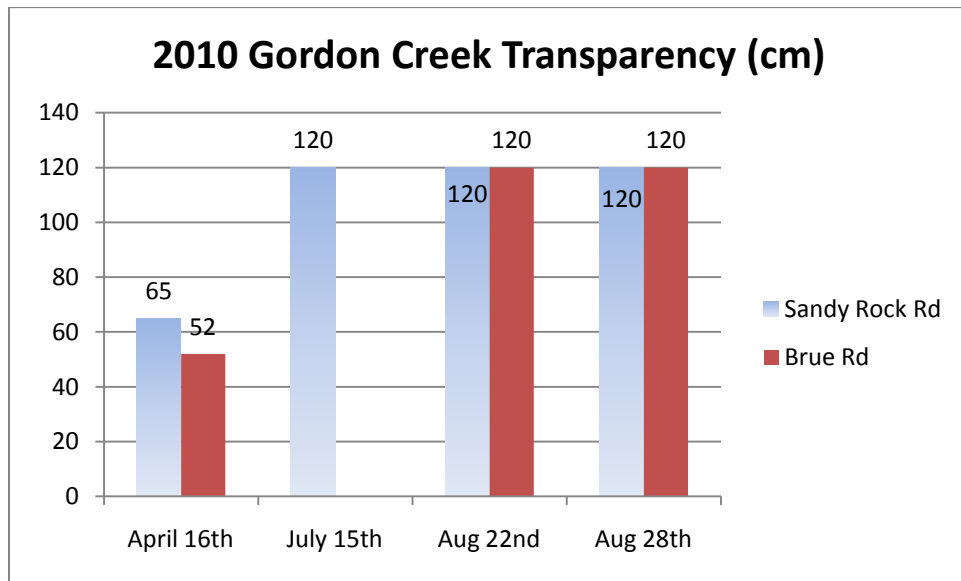
Figure 9: Gordon Creek Transparency Data

Gordon Creek is a clear trout stream during dry periods.

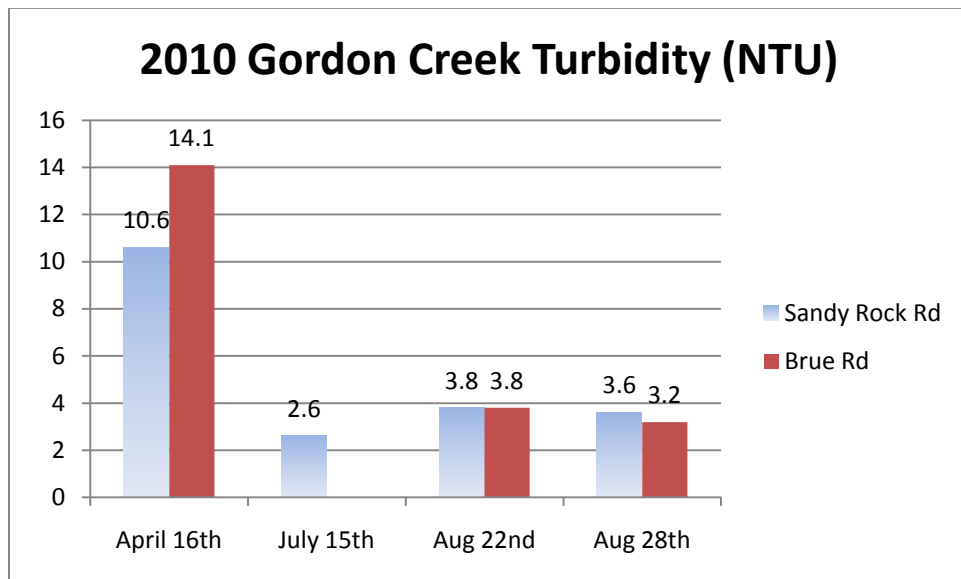
Figure 10: Gordon Creek Turbidity Levels

Turbidity measurements also reflect water clarity.

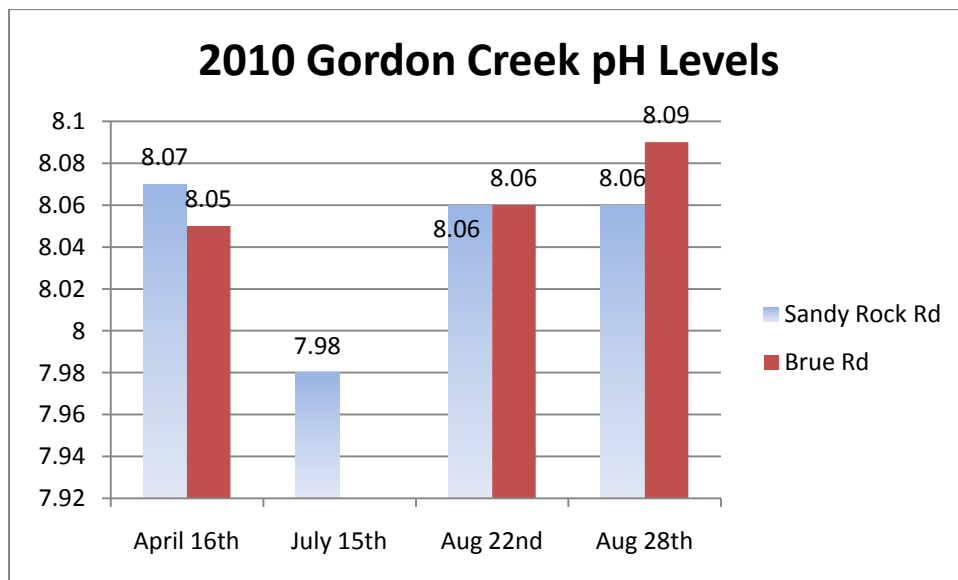
Figure 11: Gordon Creek pH Levels

Normal levels that reflect regional geology.

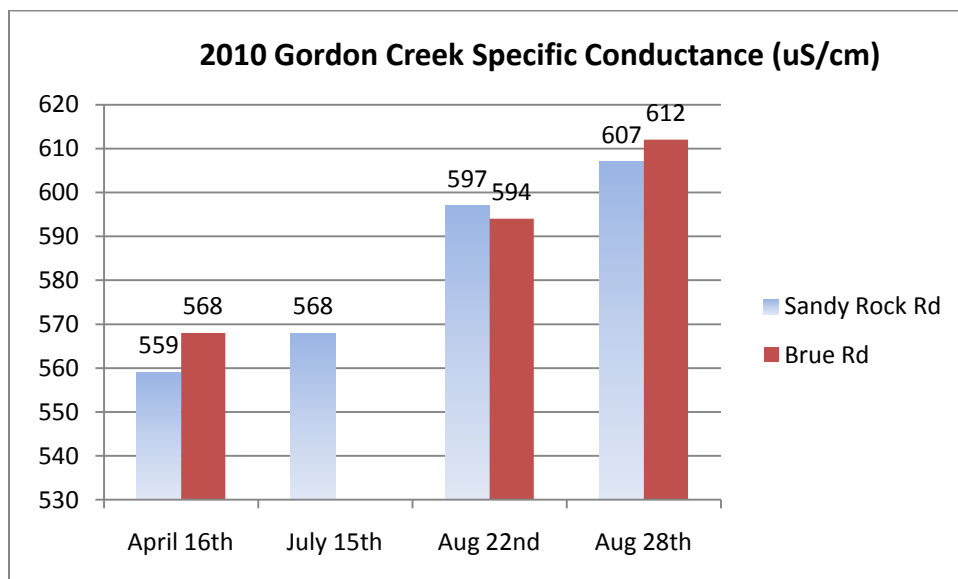
Figure 12: Gordon Creek Specific Conductance

Measure of electrical conductivity in water and indirect measure of dissolved solids. Levels typically drop when precipitation enters a stream.

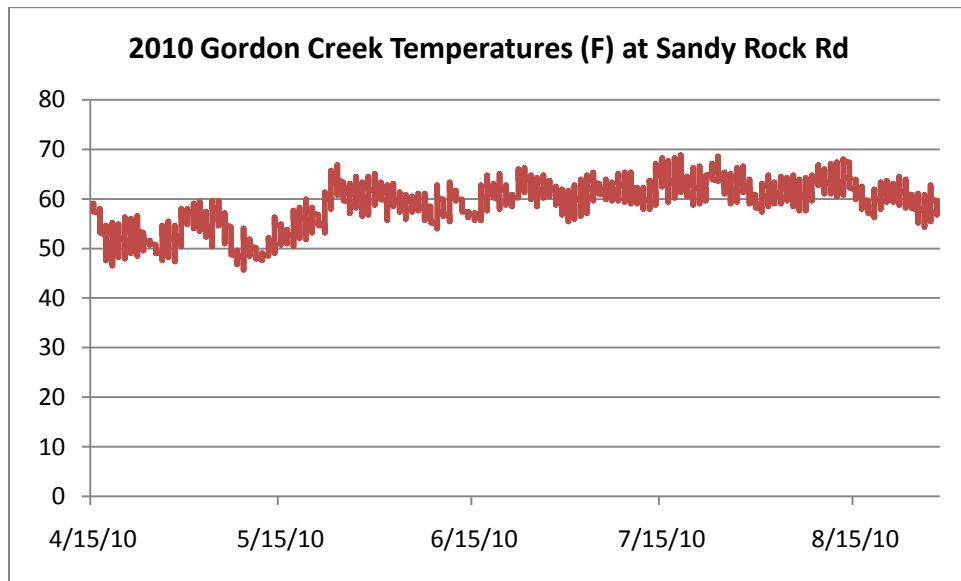
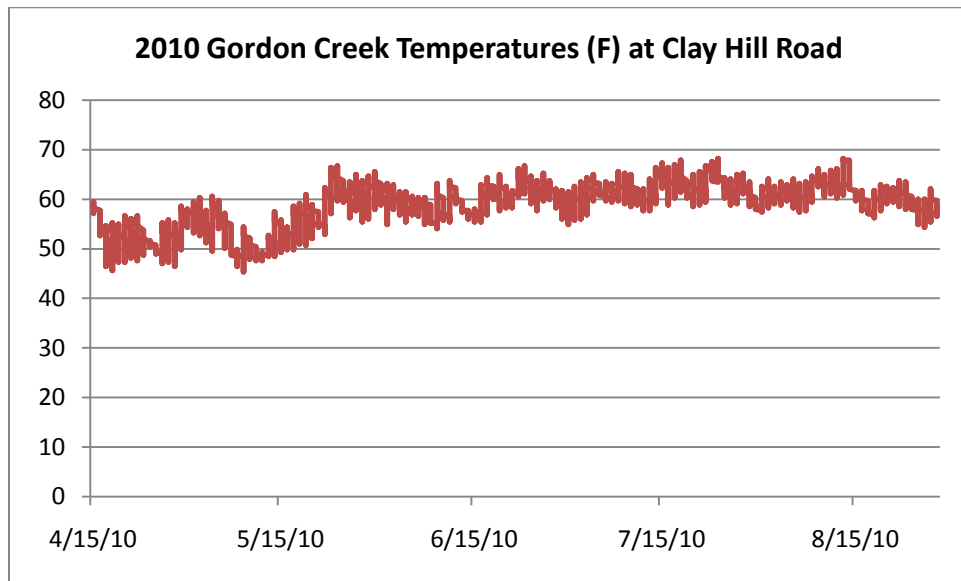
Figure 15: Gordon Creek Continuous Water Temperatures at Sandy Rock Road

Figure 16: Gordon Creek Continuous Water Temperatures at Clay Hill Road

Health cold trout stream temperatures are sustained in Gordon Creek. Data logger at Brue Road was damaged.
